Re: Dodge Avenue Water Line, City of Evanston, Illinois

EXHIBIT B – SUMMARY OF 2014 AND 2014 WORK

EXHIBIT B-2: PHOTOGRAPHS OF THE UNIDENTIFIED 24-IN PIPE ENCOUNTERED DURING 2015 WORK

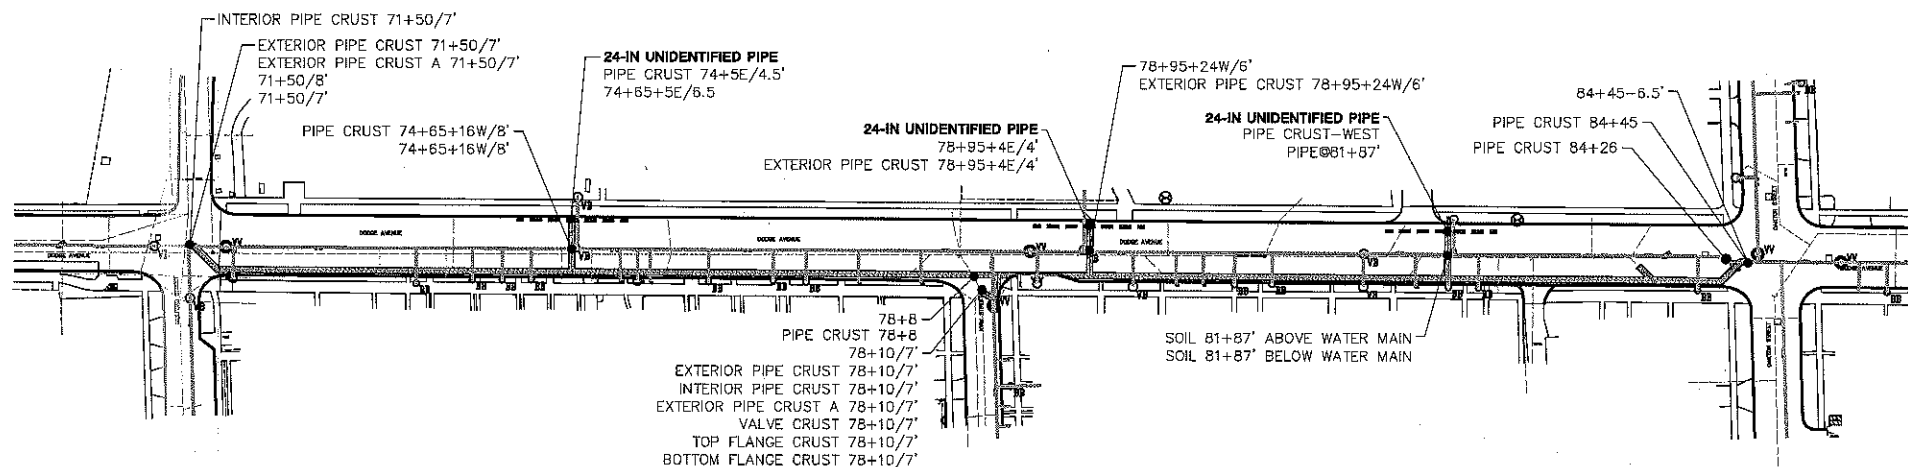
ATTACHMENT B-1A

PROJECT NO.	25214107.00	DRAWN BY:	AHB	ENGINEER	SCS ENGINEERS	CLIENT	JEEP & BLAZER, LLC. 24 N. HILLSIDE AVE. HILLSDALE, IL 60162	SITE	JAMES PARK OAKTON ST. & DODGE AVE. EVANSTON, ILLINOIS	DODGE AVE. SAMPLE LOCATIONS	EXHIBIT
DRAWN:	09/17/15	CHECKED BY:	PH		2830 DAIRY DRIVE MADISON, WI 53716-8751 PHONE: (608) 224-2830						B-1
REVISED:	09/22/15	APPROVED BY:

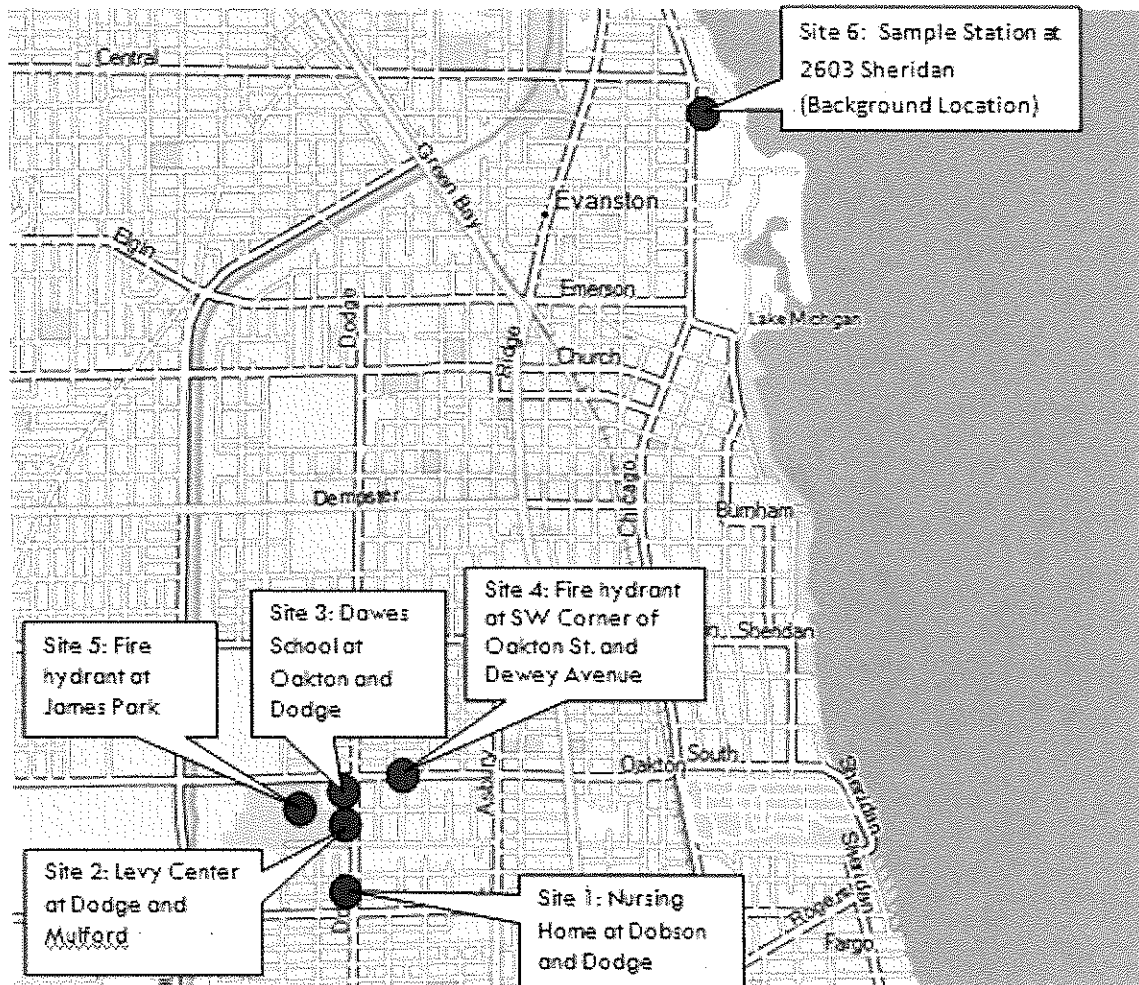
ATTACHMENT B-7

**EXHIBIT B-7 Figure Identifying Locations Where Samples Were
Collected From the City's Water Distribution System**
